Inspection date;

Three story apartment building

198 12th Street

General Observations:

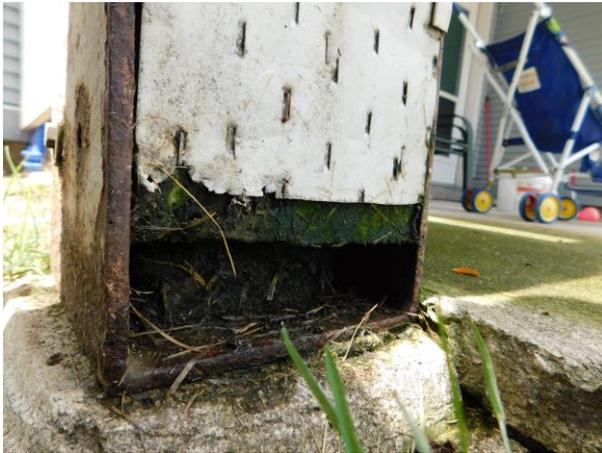
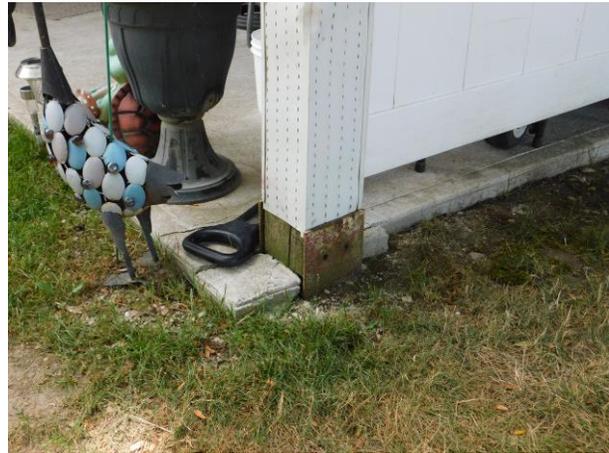
Support post foundation and saddles

The balcony support columns rest on concrete piers topped with mild steel saddles intended to mechanically connect the columns to the foundation pier. There is no evidence of sagging or slumping of the structures therefore it is assumed that the piers are providing appropriate support to the balconies. The mild steel saddles have not been treated with anticorrosion surface treatment such as rust inhibiting paint. The surface is covered in corrosion (rust) it is recommended that the saddles be cleaned of all surface rust and painted with a coat of red oxide primer and a minimum of two coats of rust inhibiting paint. There are holes drilled into the saddles to allow for a mechanical connection between the post and saddle, many of the bolts are missing or have never been installed.

View of steel saddle and support column note surface corrosion and missing bolts

Due to the numerous deficiencies, poor initial design, improperly supported joists and beams and the decaying condition of the overall structures it is our recommendation that all balcony structures be redesigned and rebuilt in their entirety.

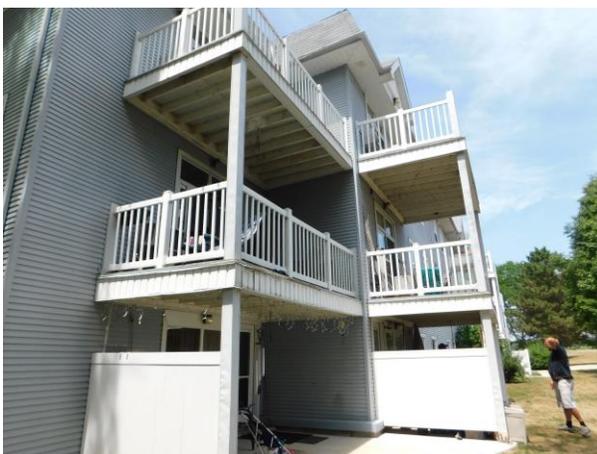
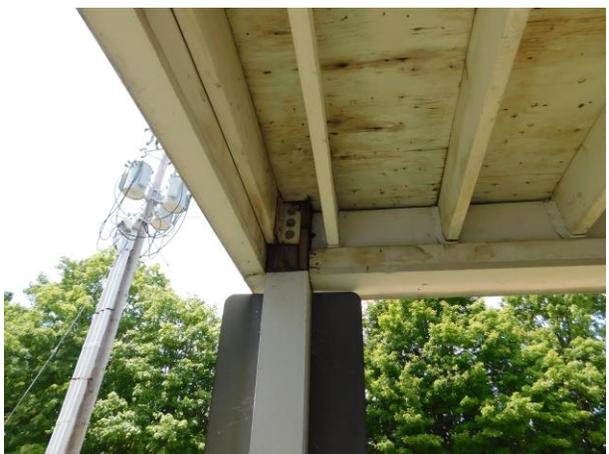
### Support Columns

The balconies are supported by continuous wooden posts at the front edge and supported on ledger strips fastened to the building at the rear of balcony. The continuous posts are covered in aluminum trim material therefore it is not possible to confirm the physical condition of the support posts. There are numerous signs water penetration behind the trim pieces therefore it is likely that some deterioration (rotting) of the columns has taken place.

There are no signs of mechanical connections between the wooden sections that make up the individual posts. This is of concern should shifting or movement take place there is nothing to prevent the posts from becoming misaligned and collapsing.

The support columns are continuous, the above photo depicts the wooden posts stacked one on the other with little in the way of mechanical connection at the joints to provide stability.

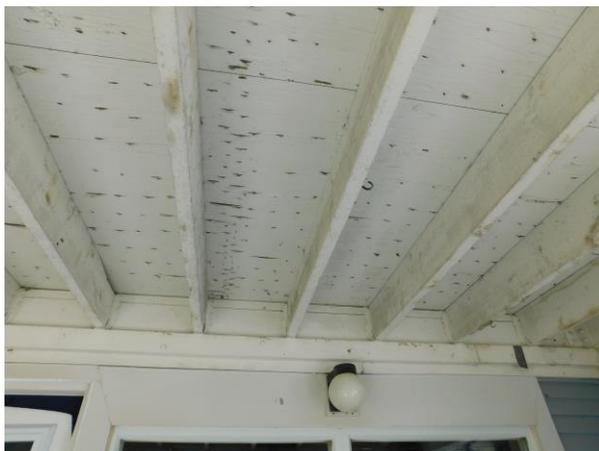
### Support beams and ledgers

Support beams are constructed from built up wooden joists. The support beams are connected to the face of the columns using a combination of nails, lag screws and bolts. This provides for a very weak joint susceptible to failure due to fastener fatigue or wood decomposition. The rear of the balcony joists are fastened to a ledger strip that appears to be fastened to the building by lag screws. The floor joists are supported by a wooden support strip and joists hangers,. The joist hangers used for the construction appear to be designed for indoor use and not appropriate for the balcony deck construction, these should be replaced with a product designed for exterior use. The ledger strips should be mechanically attached to the structure using a bolt system with space between the ledgers and building face provided for storm water drainage and air circulation and flashed at the top to prevent water egress.

Above photo depicts the connection of the joists to the ledger strip. The joist hangers have been painted making them difficult to identify in this photo.

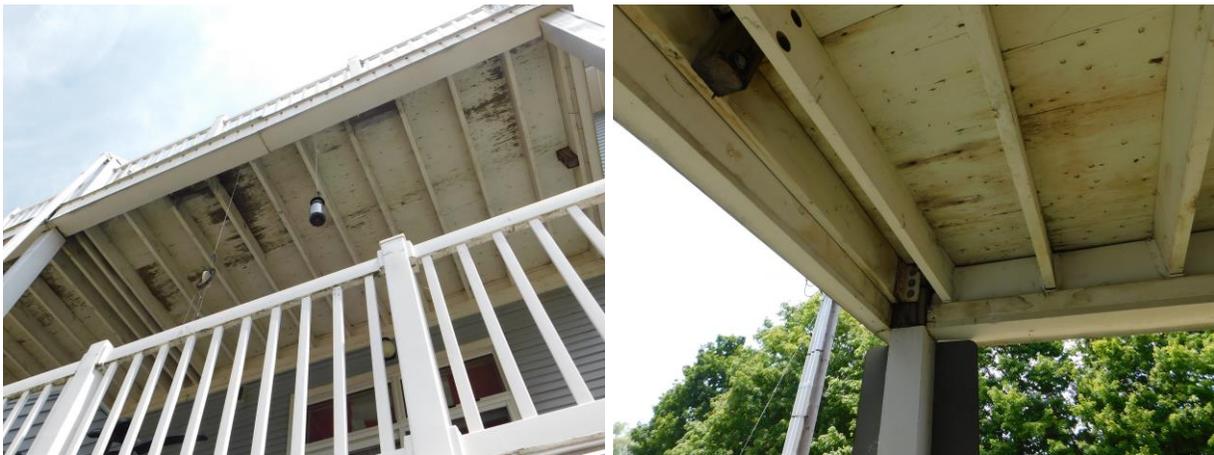
The balcony decks consist of plywood sheathing, it appears that a prior repair may have taken place where an additional layer of plywood was installed over the original. The plywood deck sheathing has been covered with paint on membrane. Deck sheathing is soft and spongy in many areas and at the end of service life.

Underside of balcony decks depicting deteriorated plywood sheathing

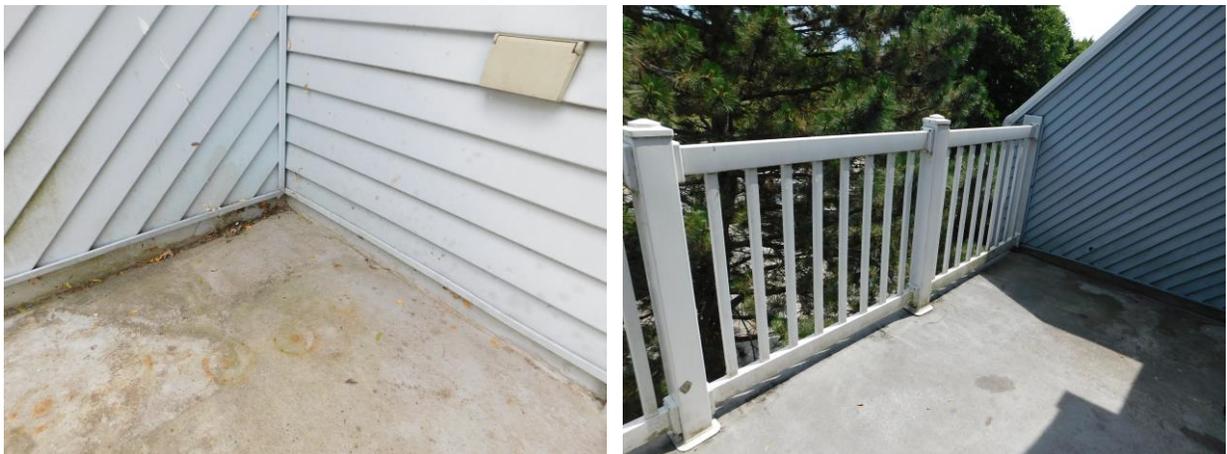
Top surface of balcony decks note paint on membrane

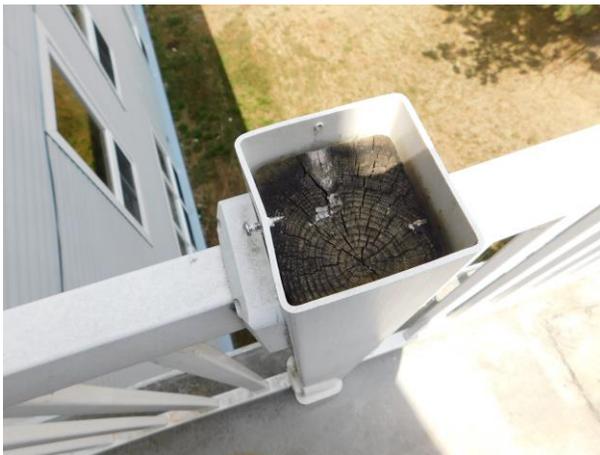
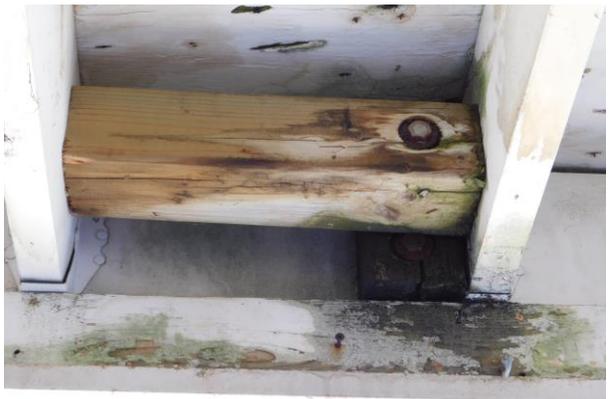
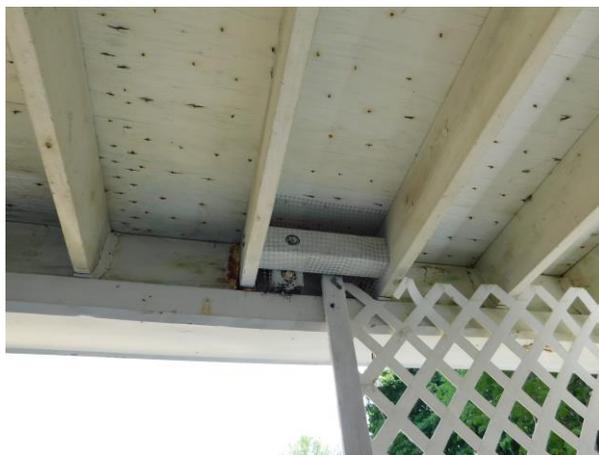
Balcony guards (railings)

The balcony guards do not comply with current building code requirements and in our opinion unsafe. The railing system and posts exhibit significant movement when pushed against with moderate force. Deterioration of support posts were noted in many areas, intermediate support posts were not properly framed in to the deck floor joists.

Decaying and improperly supported railing posts

A suggestion would be to construct the new balconies using a structural steel frame with wood joists and decking. This approach would provide a long lasting structure that could be more easily maintained while provide a more structurally sound attachment point for a new railing system. It is our opinion that this approach would provide a long lasting, cost effective solution.
