**20 WADE AVENUE
GROUND AND 2ND FLOOR PLAN**

client: **TAMIL CO-OPERATIVE HOMES INC.**
 project: **DESIGNATED SUBSTANCES AND HAZARDOUS MATERIALS SURVEY
20 WADE AVENUE
TORONTO, ONTARIO**
 title: **GROUND AND 2ND FLOOR PLAN**
 project no: **ENVSETOB10466AA** drawing no: **2**

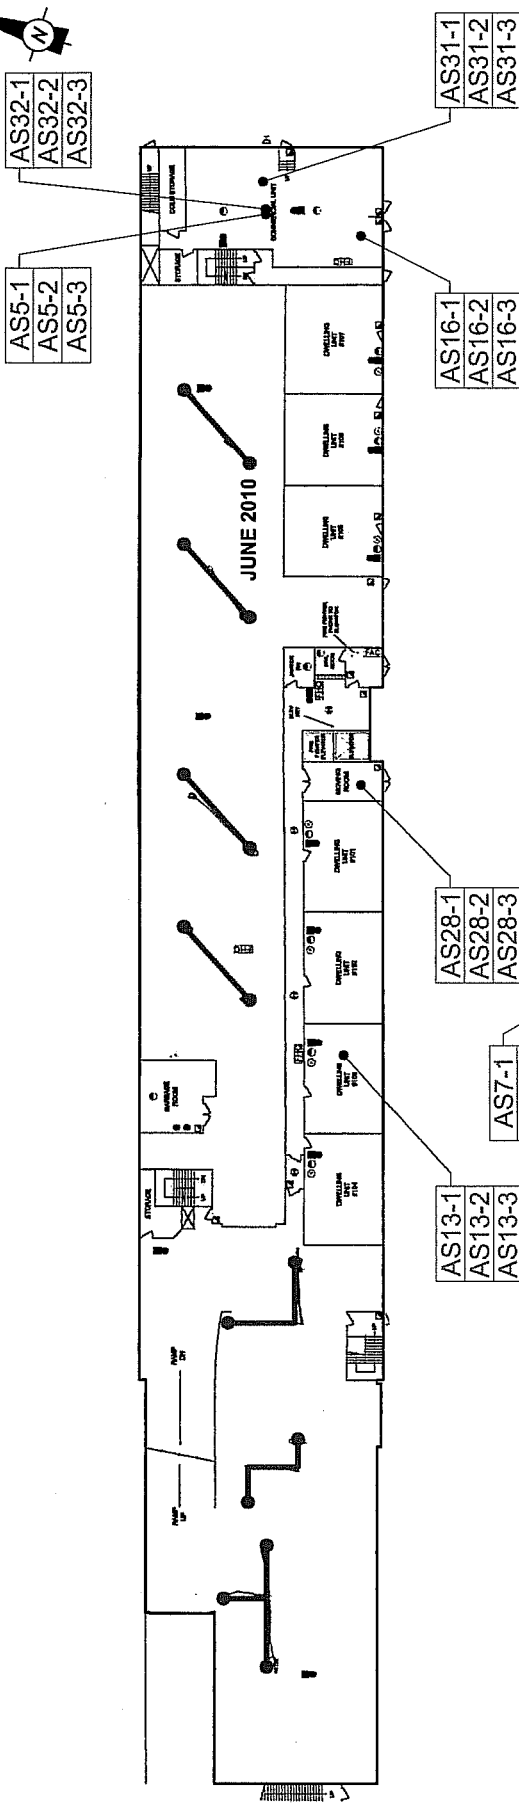
Ground Floor

Note: 1. Asbestos containing transite piping was observed on roof drain pipes throughout the parking garages. It is expected that asbestos containing transite piping is located in inaccessible areas throughout the building.

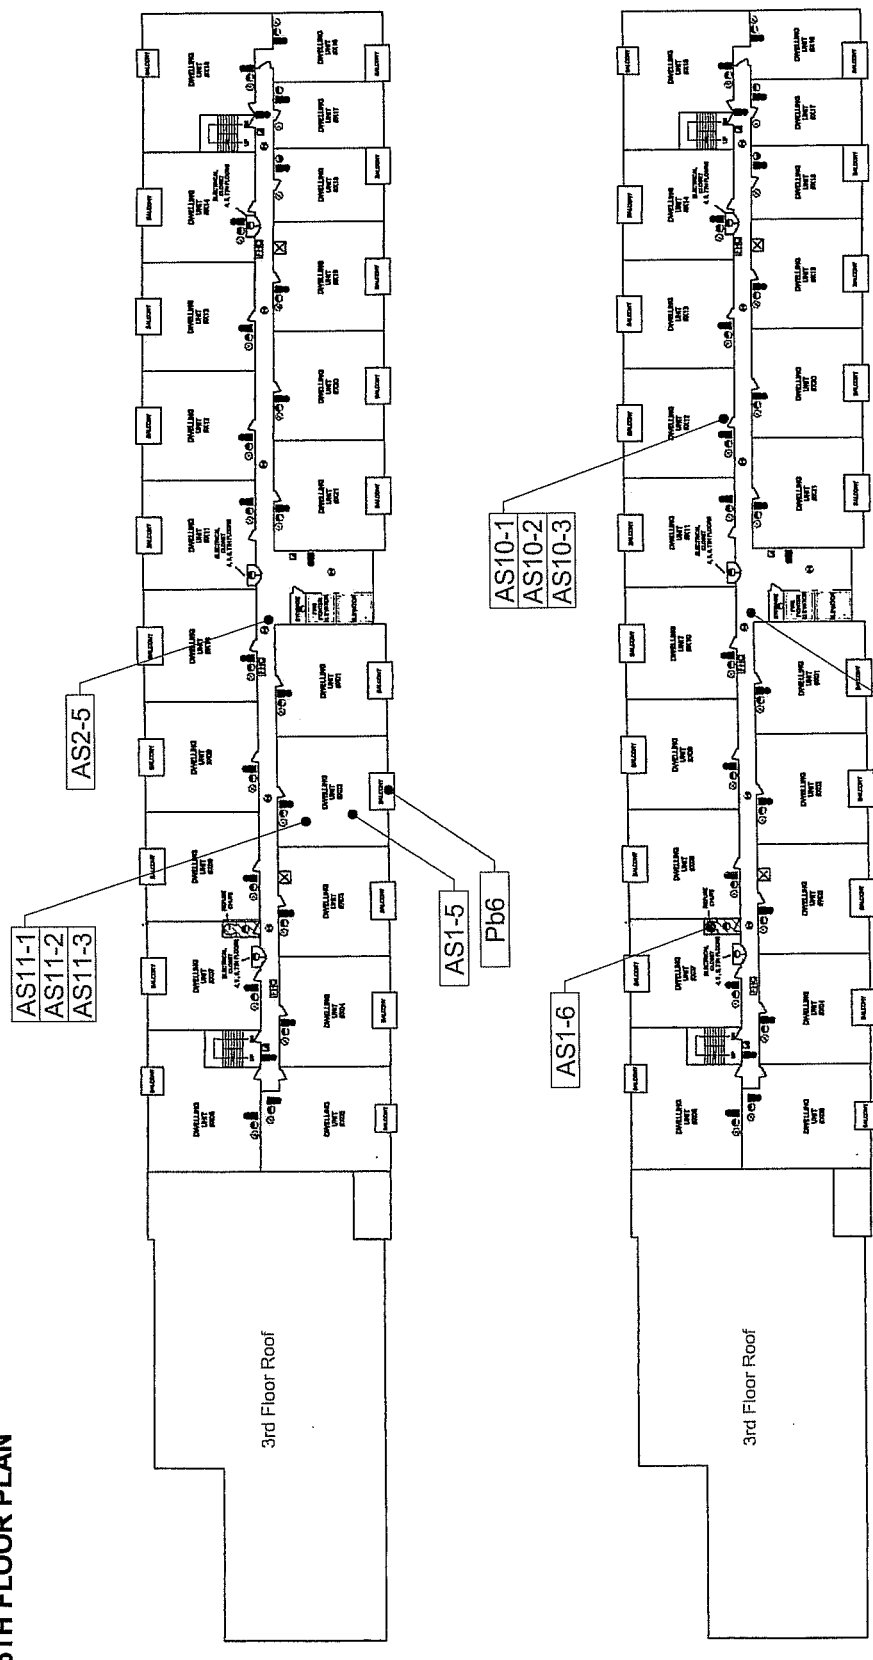
6th Floor

Note: 1. Asbestos containing transit piping was observed on roof drain pipes throughout the parking garages. It is expected that asbestos containing transit piping is located in inaccessible areas throughout the building.

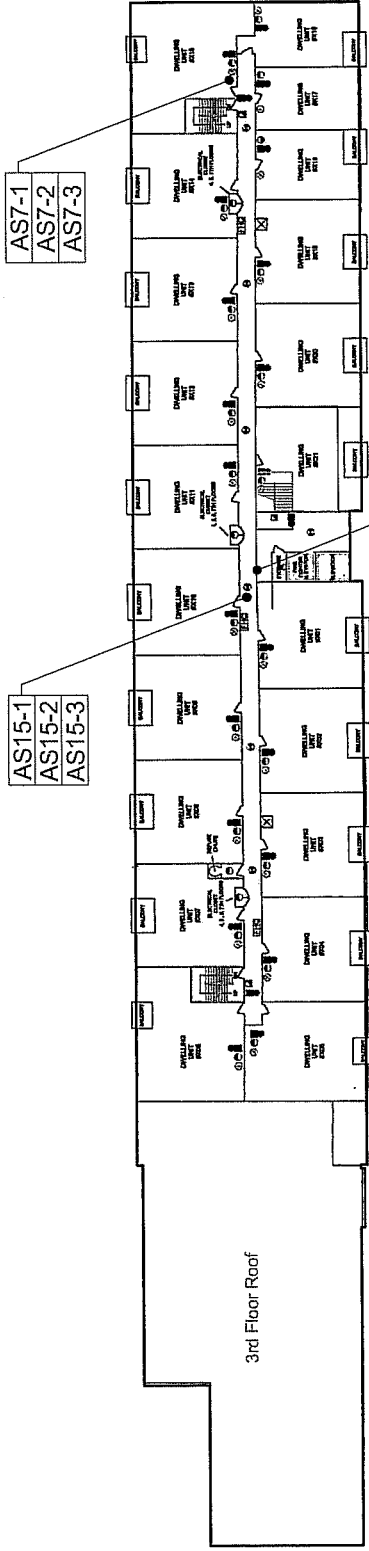
8th Floor

Note: 1. Asbestos containing transite piping was observed on roof drain pipes throughout the parking garages. It is expected that asbestos containing transite piping is located in inaccessible areas throughout the building.

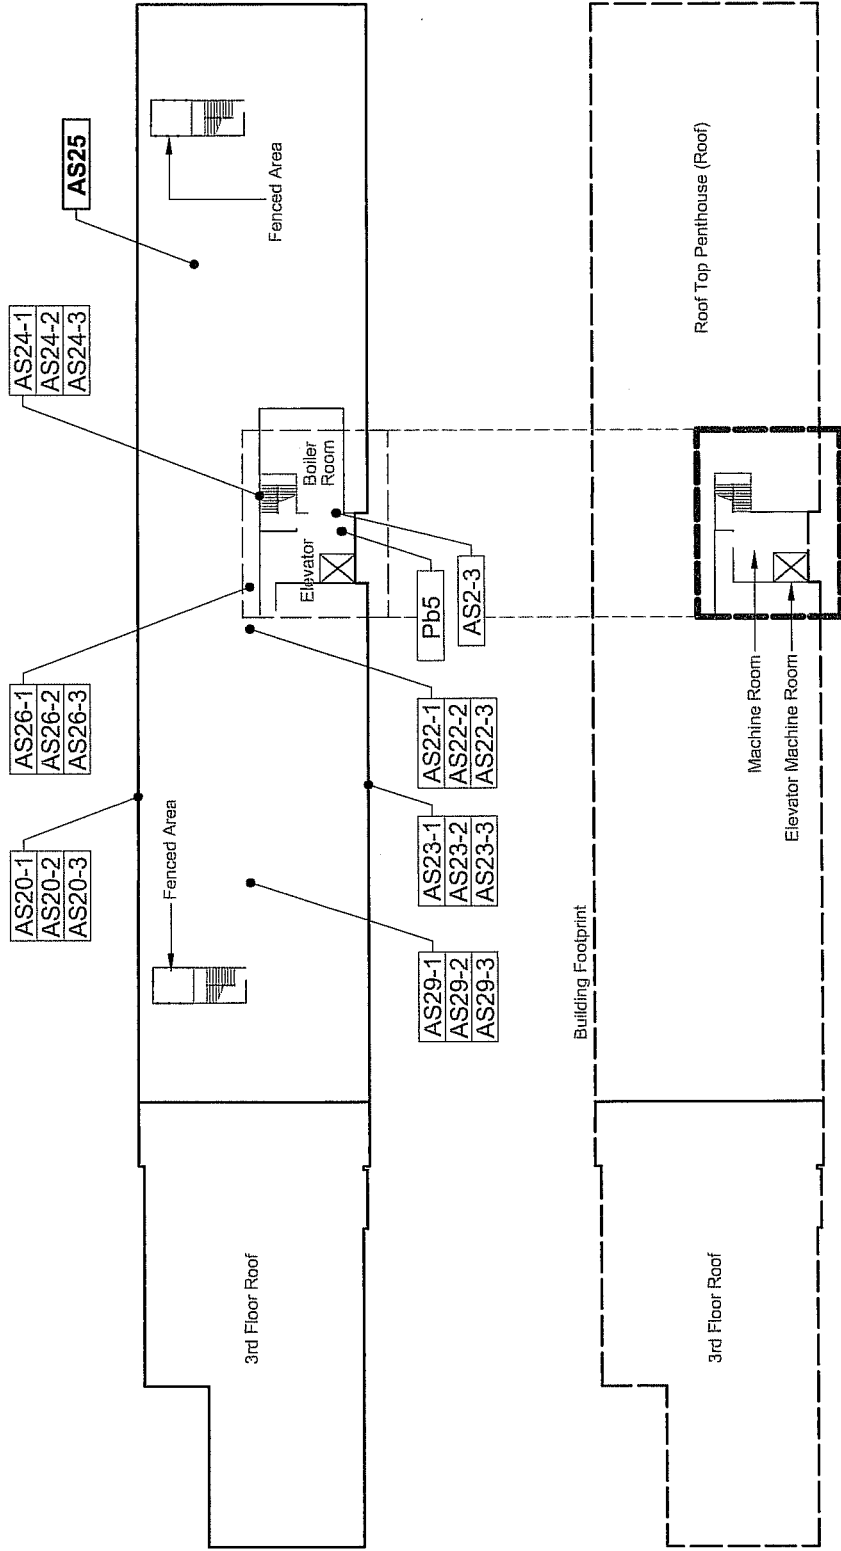
Roof Top Penthouse

Notes:
 1. Asbestos containing transite piping was observed on roof drain pipes throughout the parking garages. It is expected that asbestos containing transite piping is located in inaccessible areas throughout the building.
 2. Asbestos containing caulking was observed on the exhaust fans observed on the roof.
