Appendix B

Site Photographs

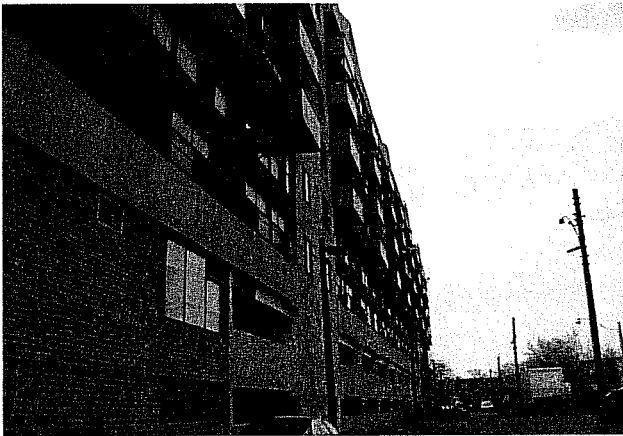
1. Exterior view of subject site facing southwest.

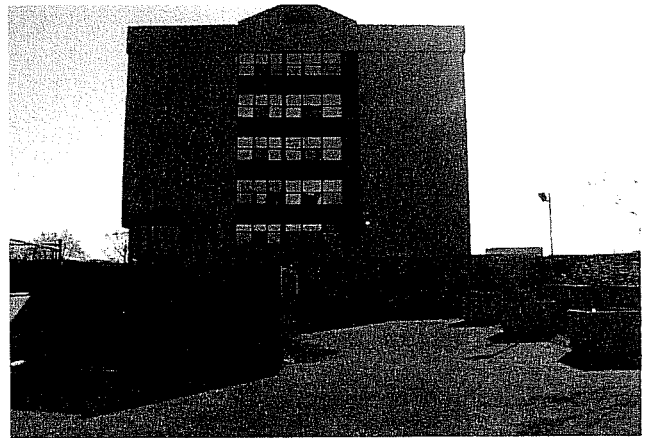
2. View of 3rd floor landscaped roof facing east.

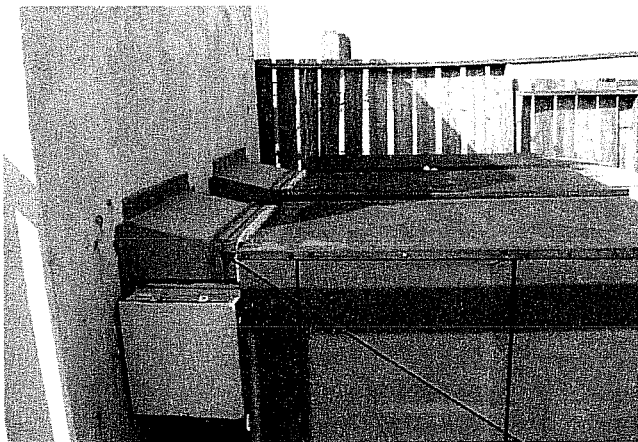
3. View of rooftop penthouse exhaust metal casing with asbestos containing black caulking.

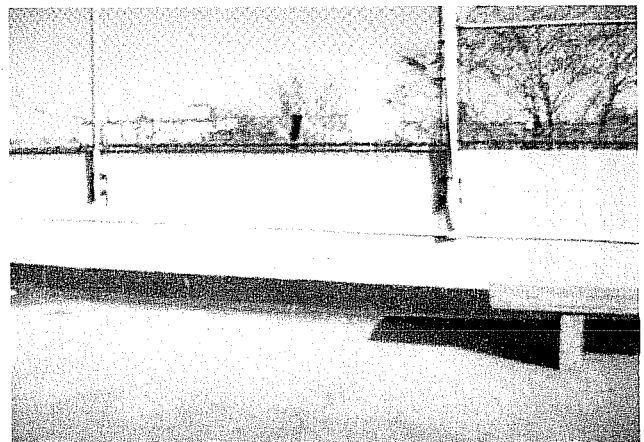
4. View of 3rd floor landscape roof flashing with asbestos containing grey caulking.

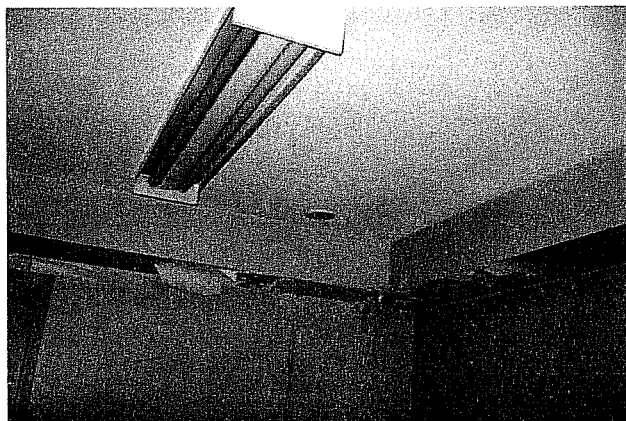
5. View of water damage in 3rd floor meeting room kitchen.

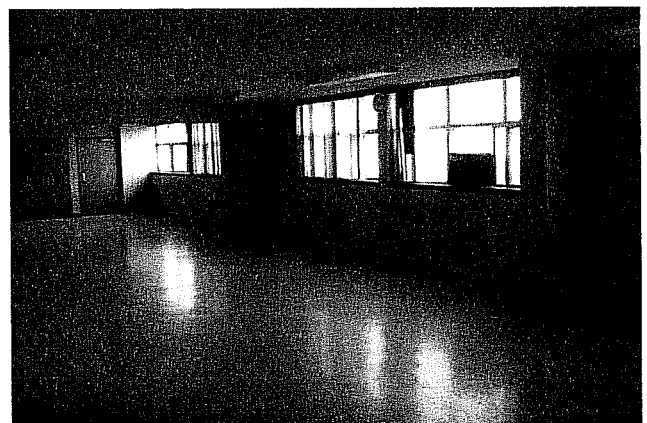
6. View of 3rd floor meeting room with asbestos containing vinyl floor tiles.

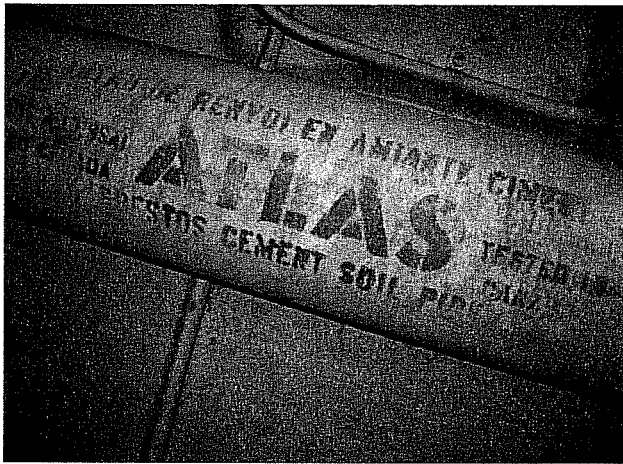
7. View of asbestos containing transite pipes.

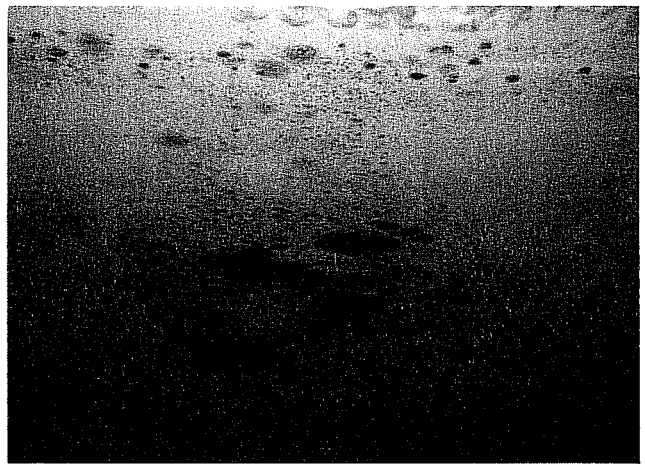
8. View of mould on ceiling of 2nd floor parking garage.
